elements of **STYLE**

Parras residence

Austral Bricks® Elements®
Zinc semi-glazed clay bricks

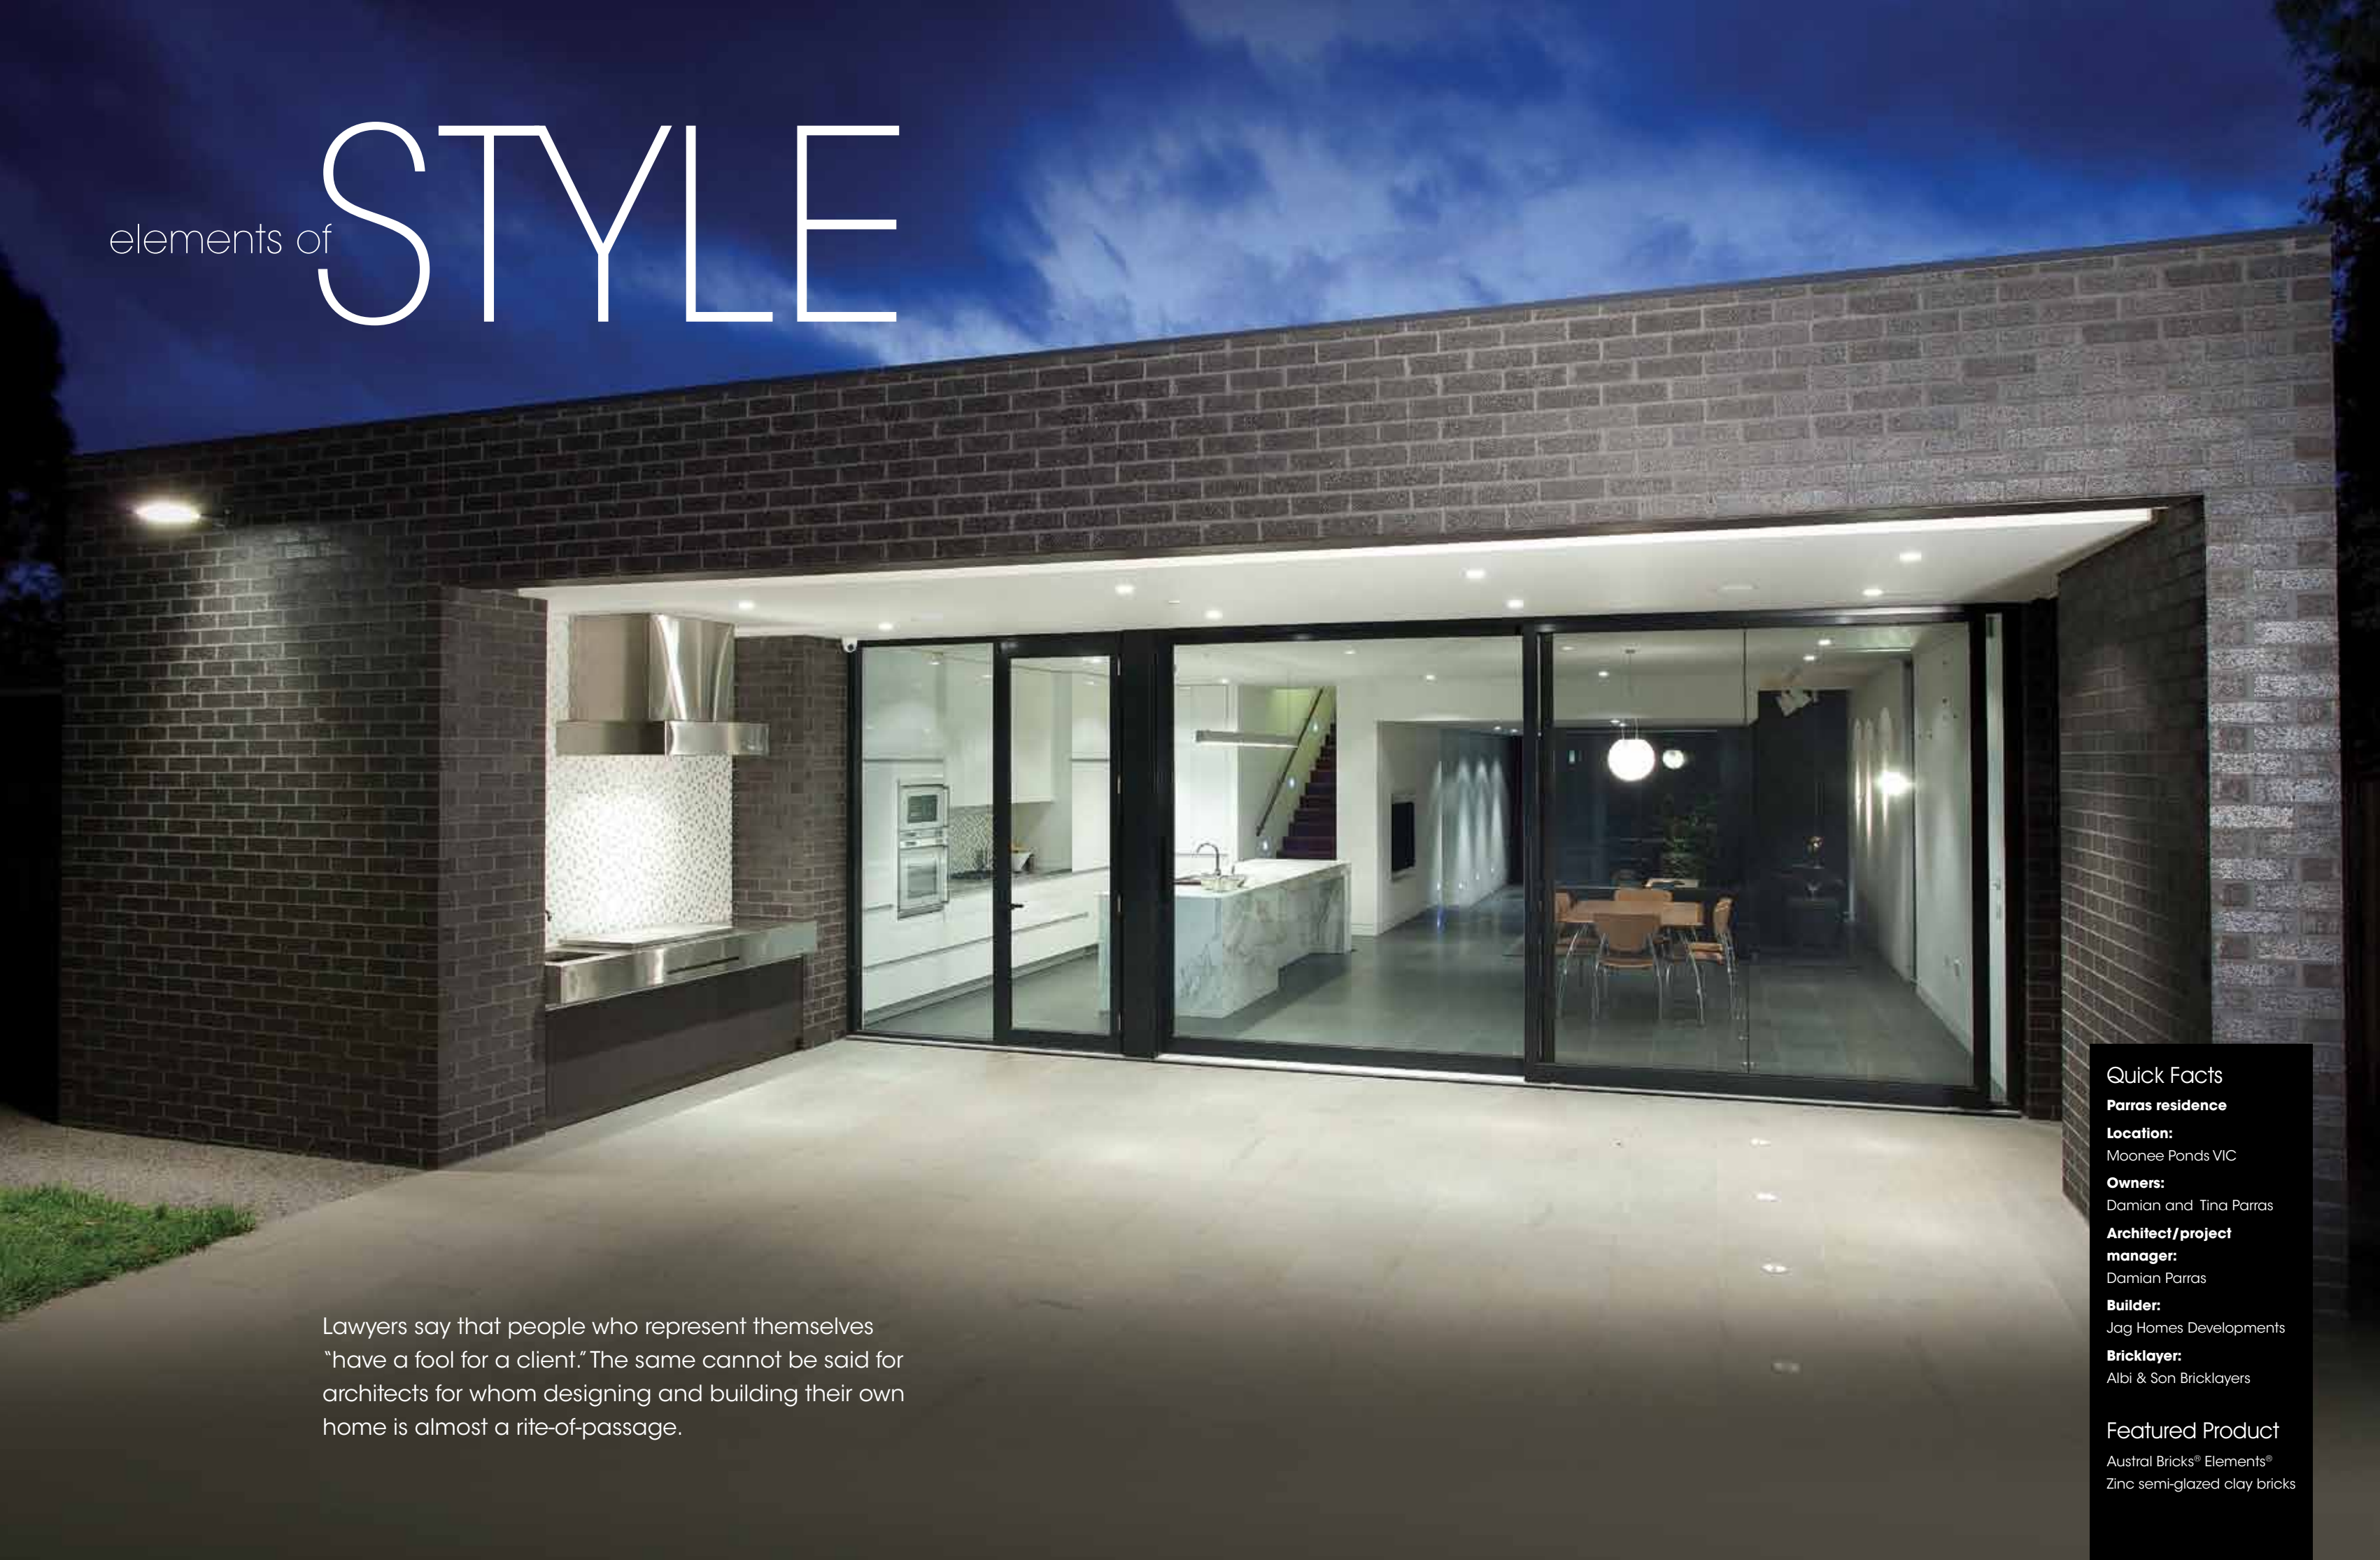
previous page. As dusk falls the glaze of the bricks takes on a glow. The brickwork spanning the outdoor room is supported on an L-shaped lintel.

To the rear, an outdoor room with a built-in barbecue connects the dining area, kitchen and main living area with the east-facing backyard via massive sliding glass doors. The nine courses of brickwork spanning the opening are supported on an L-shaped lintel.

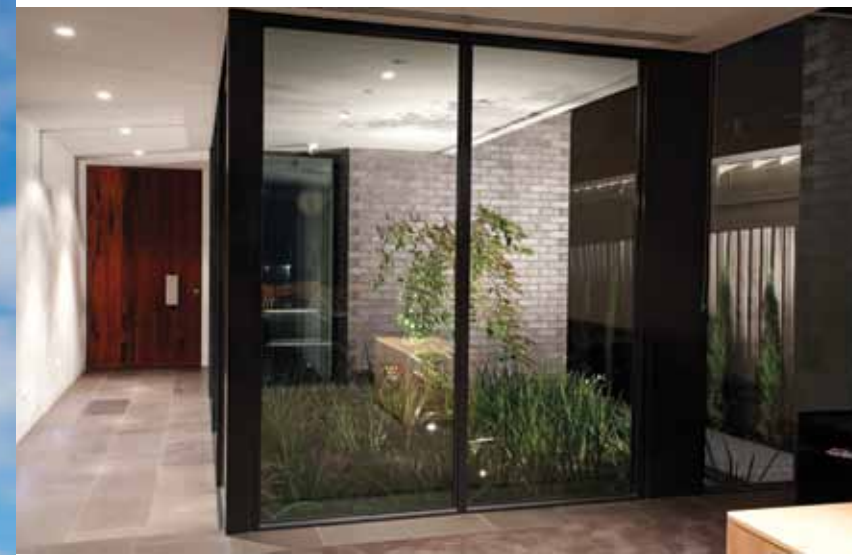
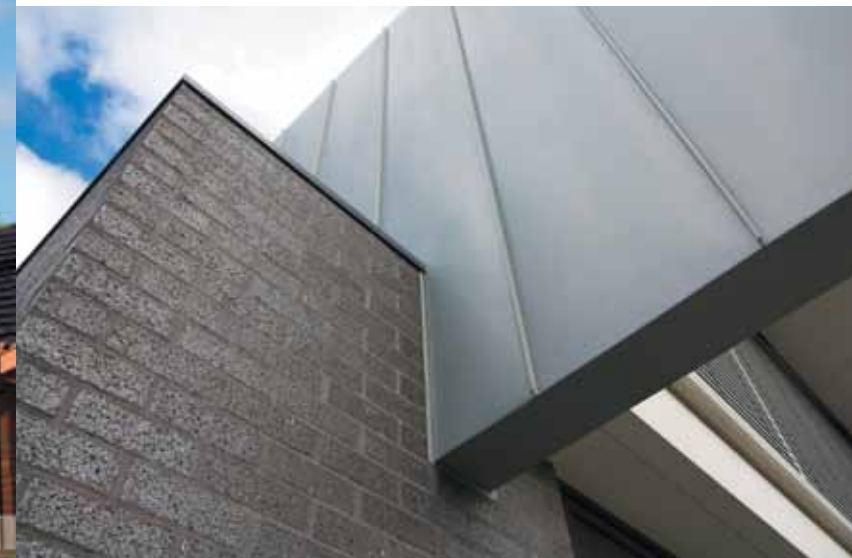
from left. The zinc-clad upper level floats above the more grounded brickwork. A glazed internal courtyard draws light into the centre of the house along the narrow northern boundary. Architect Damian Parras describes brickwork as "an honest and very durable material."

view. The solution was to design a glazed internal courtyard that captures the northern sun while maintaining a garden outlook. It also preserves the house's flow-through design, allowing a direct visual connection to the street, even though the main living areas are to the back of the house.
